Biomedical Instrumentation

naydin@yildiz.edu.tr naydin@ieee.org http://www.yildiz.edu.tr/~naydin Electrical Safety

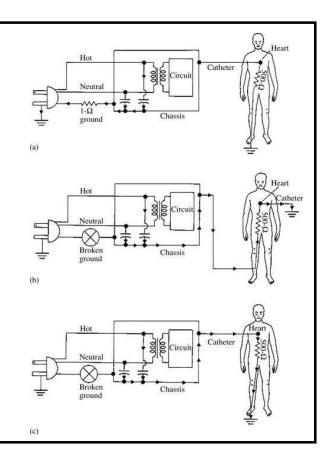
Figure 14.11 Microshock leakage-current pathways. Assume 100 μ A of leakage current from the power line to the instrument chassis, (a) Intact ground, and 99.8 μ A flows through the ground, (b) Broken ground, and 100 μ A flows through the heart, (c) Broken ground, and 100 μ A flows through the heart in the opposite direction.
